# Abbeytown Home Inspection LLC

## Home Inspection Report

Inspected on Tue, Apr 28 2015 at 6:59 PM

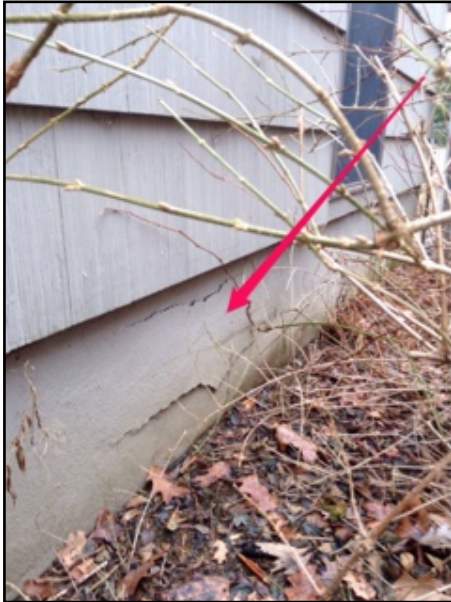
Figure 1-1

Any vegetation touching the house should be cut back or removed,can cause excessive moisture that can damage the home.Photo shows damage due to vegetation not allowing wall to dry properly.

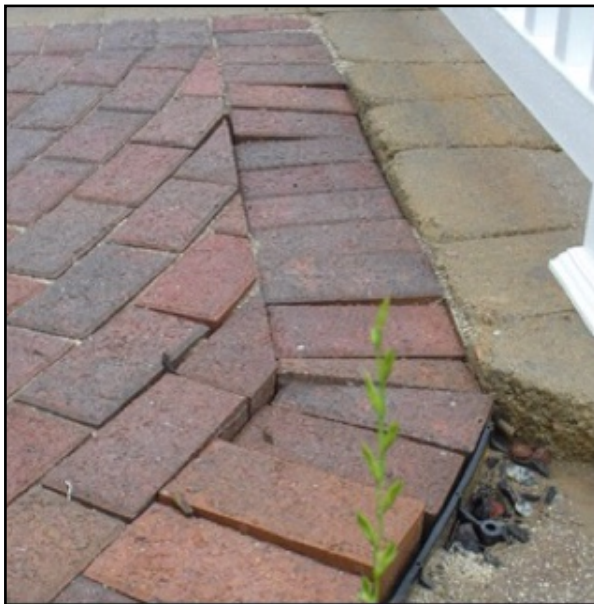
Figure 2-1

Uneven bricks in the walkway are a trip hazard,evaluation and repair by a qualified professional .

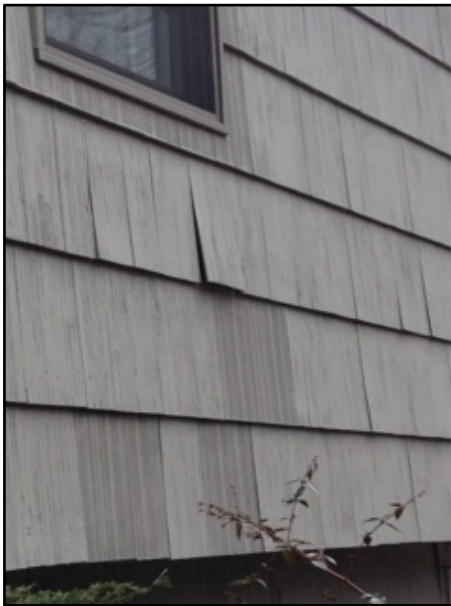
Figure 3-1

Comment 3:  
Bowling an cracking of wood shingles,further evaluation by a licensed professional .

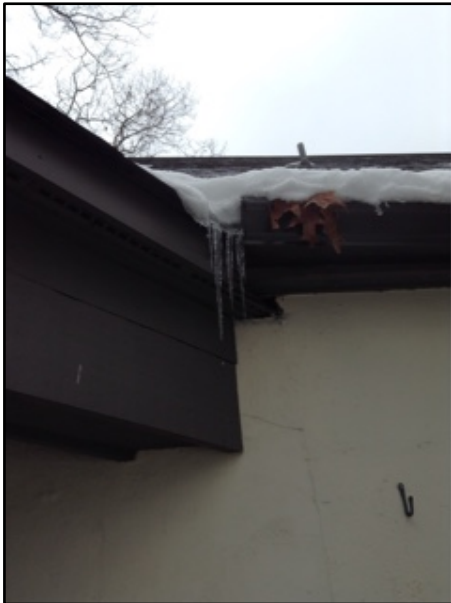
Figure 4-1

Wood trim needs repair in some places and should be evaluated by licenced professional .

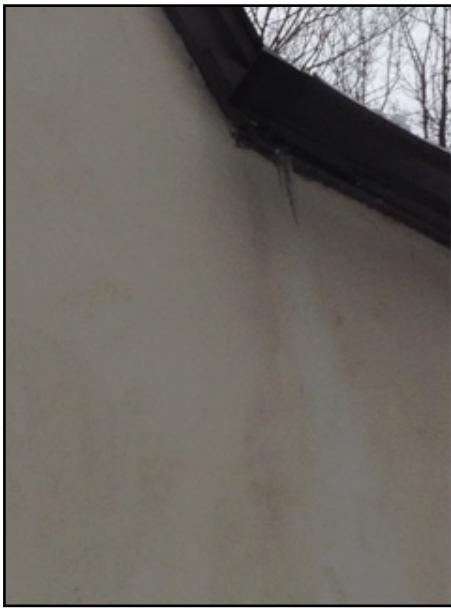
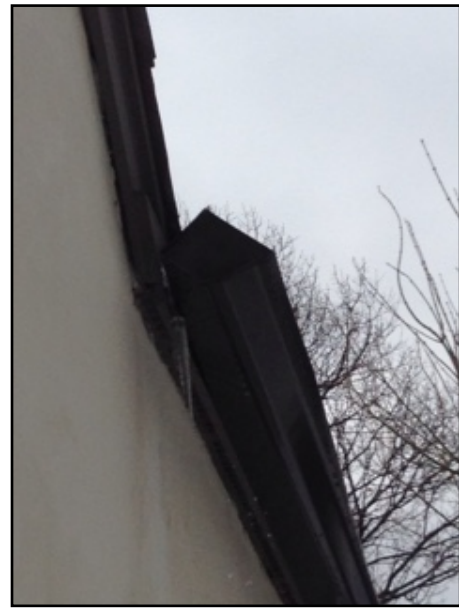
The gutters appeared new but have been damaged by ice and snow, repair by licenced professional .

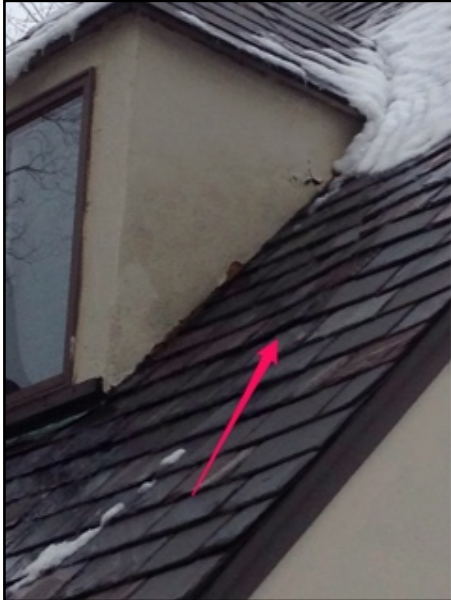
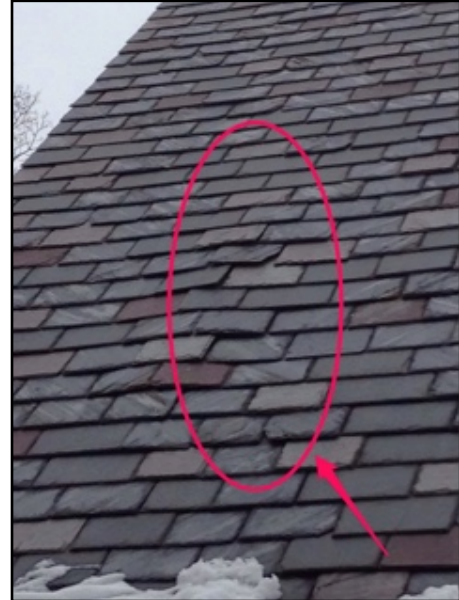
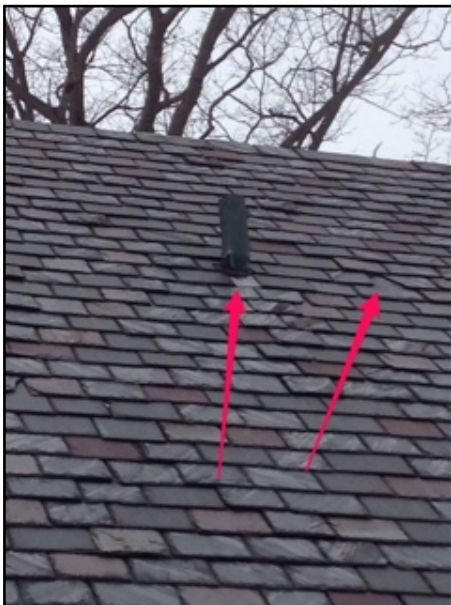
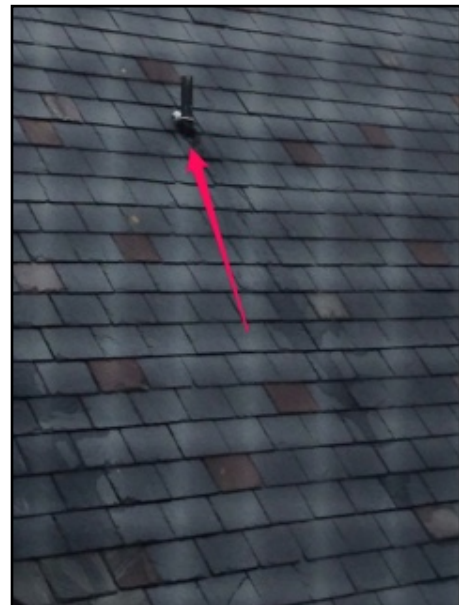
Loose and missing states,also some broken.Vent flashing should be checked, further evaluation by licenced roofing professional

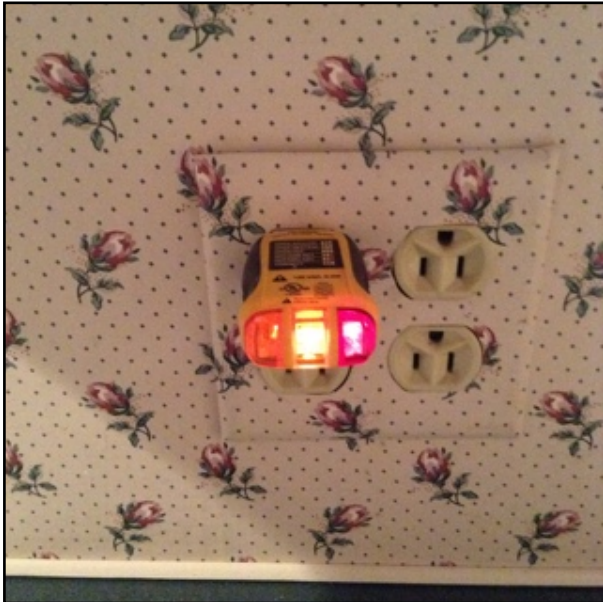
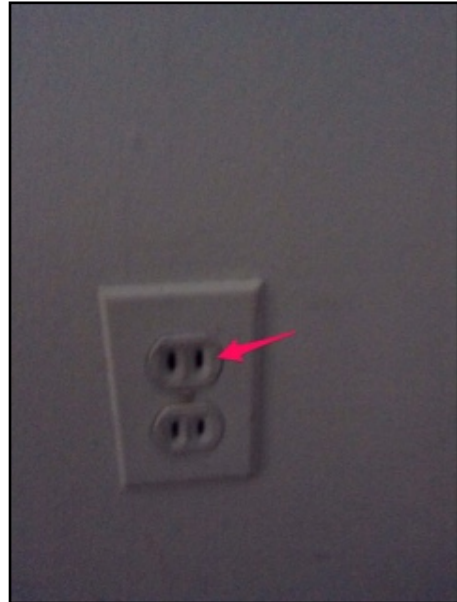
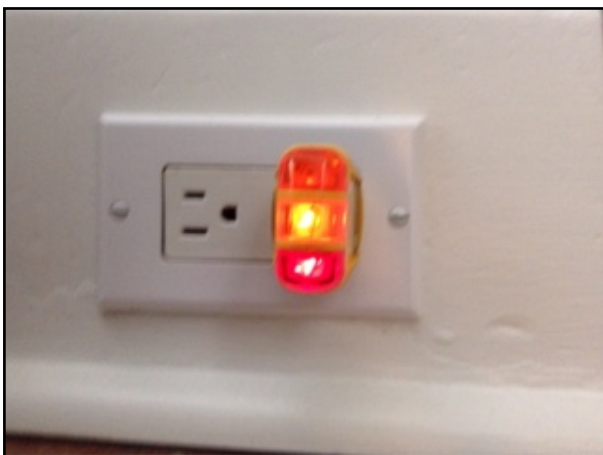
Electrical outlets with reverse polarity present also outlet without ground,needs evaluation by licenced electrician.

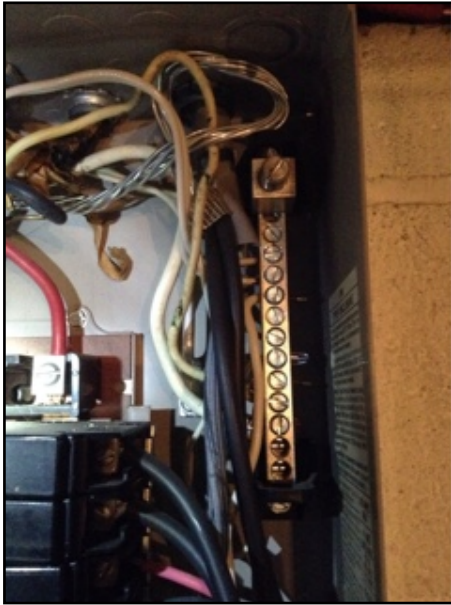
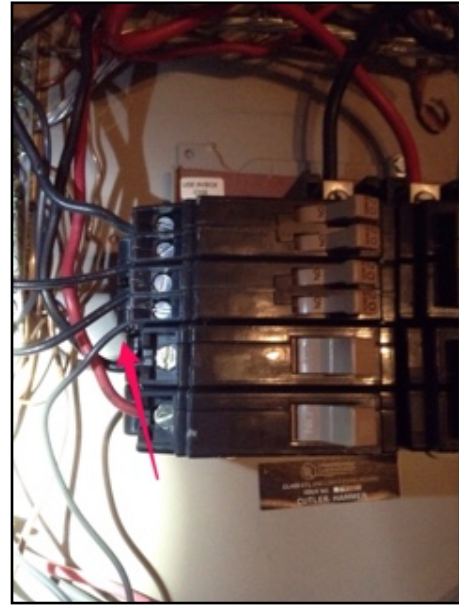
Sub panel should be evaluated by licenced electrician .

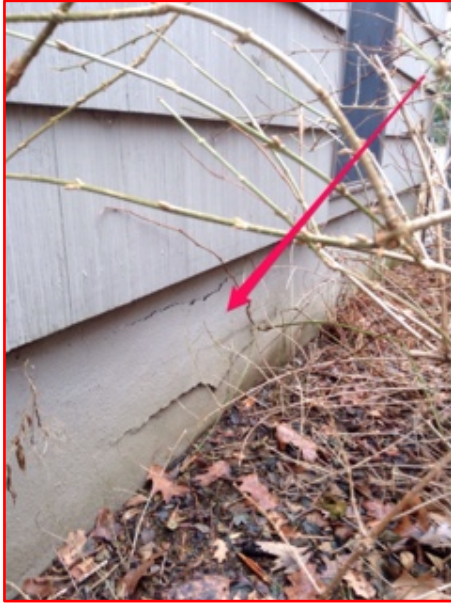
Figure 1-1

1) Any vegetation touching the house should be cut back or removed, can cause excessive moisture that can damage the home. Photo shows damage due to vegetation not allowing wall to dry properly.

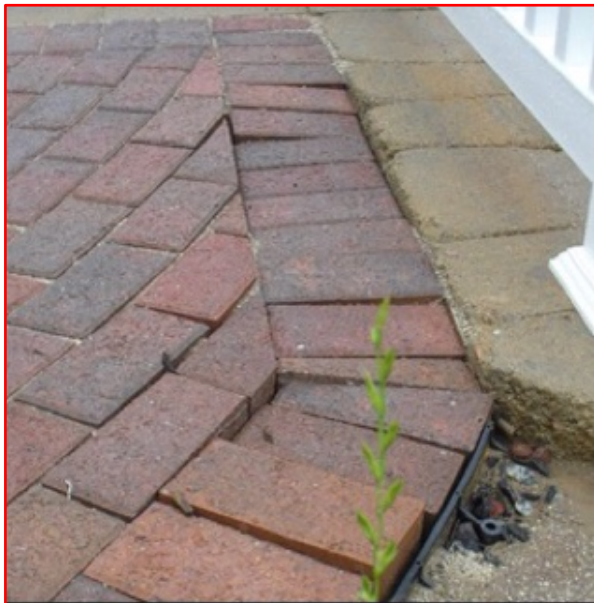
Figure 2-1

2) Uneven bricks in the walkway are a trip hazard, evaluation and repair by a qualified professional .

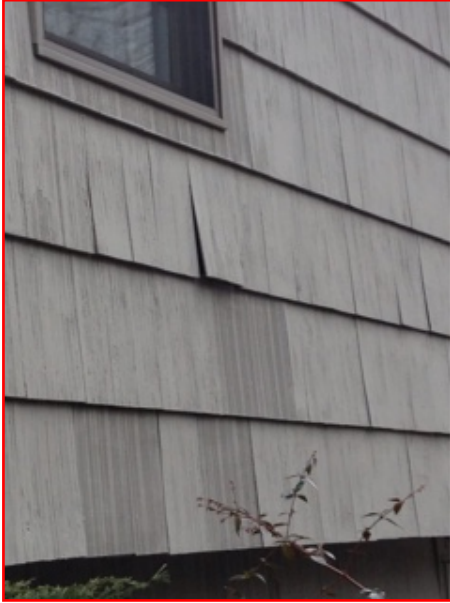
Figure 3-1

3) Bowing and cracking of wood shingles, further evaluation by a licensed professional .

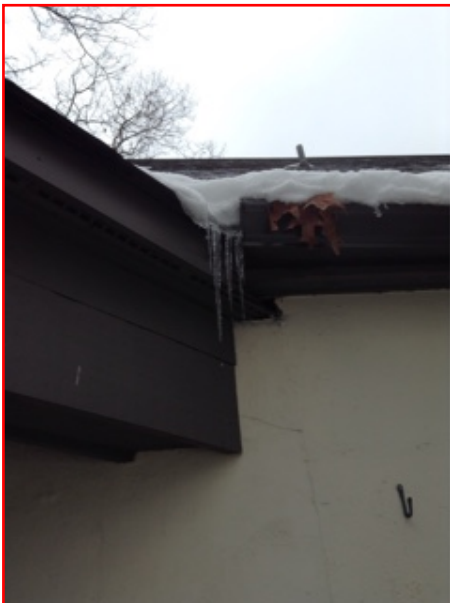
Figure 4-1

4) Wood trim needs repair in some places and should be evaluated by licensed professional .

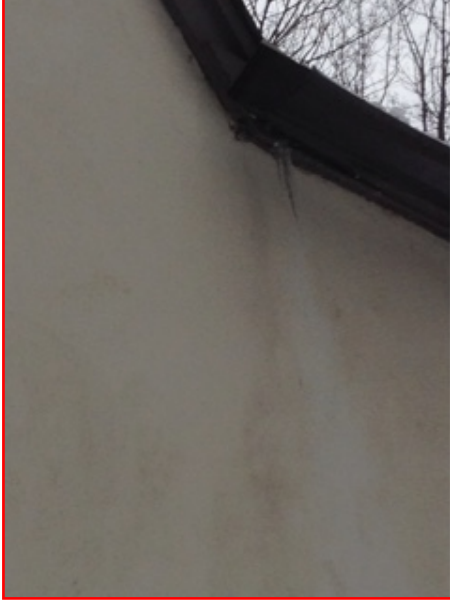
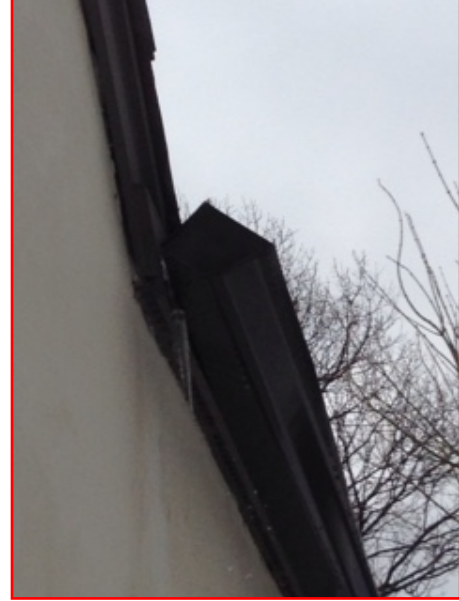
5) The gutters appeared new but have been damaged by ice and snow,repair by licenced professional .

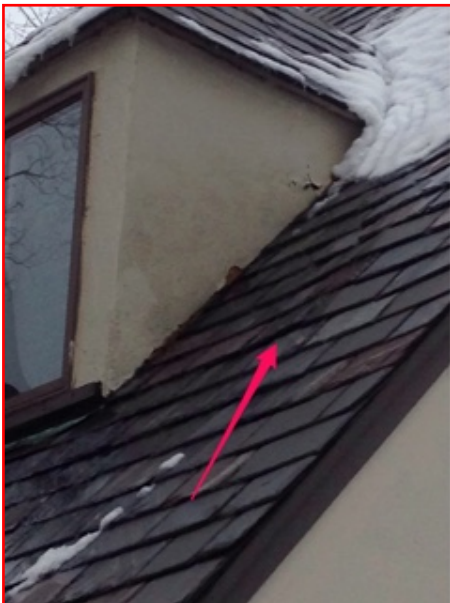
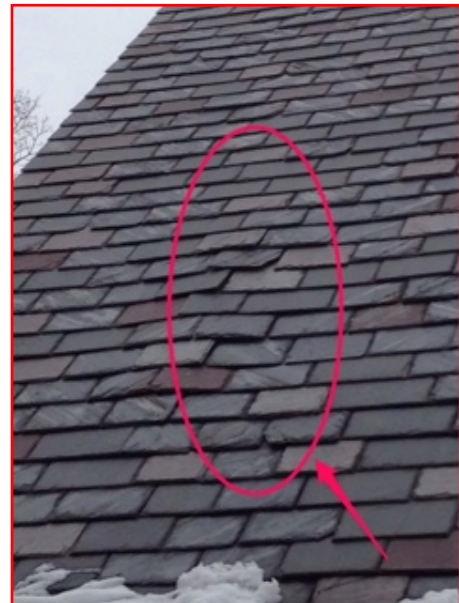
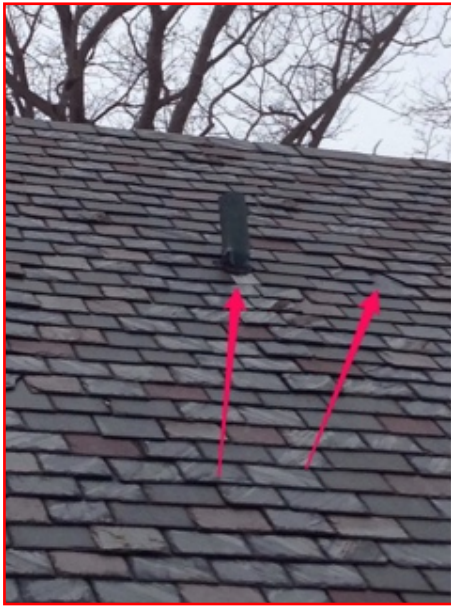
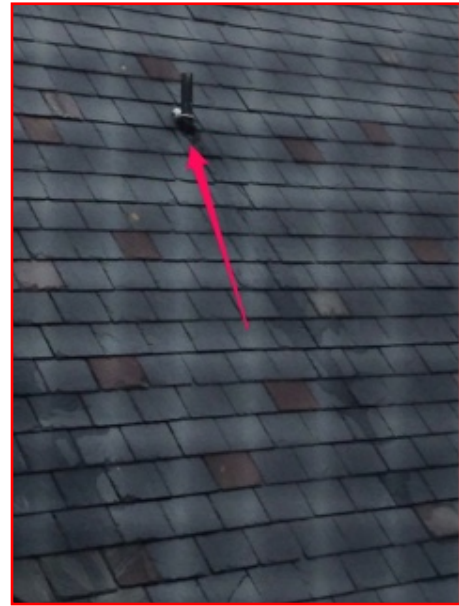
6) Loose and missing states,also some broken.Vent flashing should be checked, further evaluation by licenced roofing professional

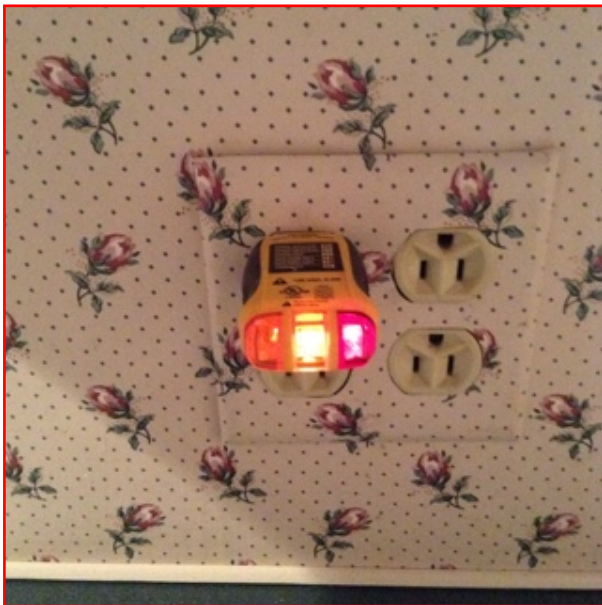
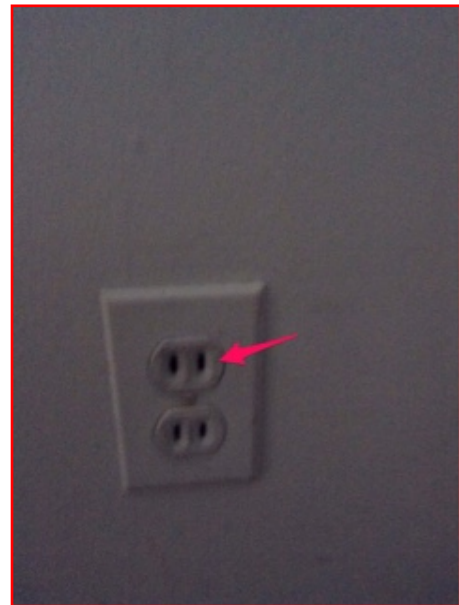
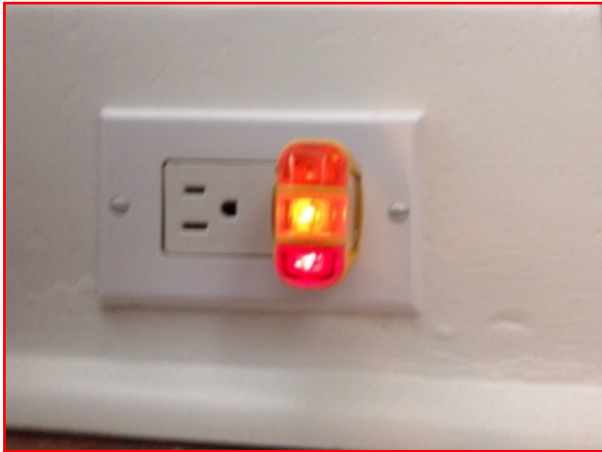
7) Electrical outlets with reverse polarity present also outlet without ground,needs evaluation by licenced electrician.

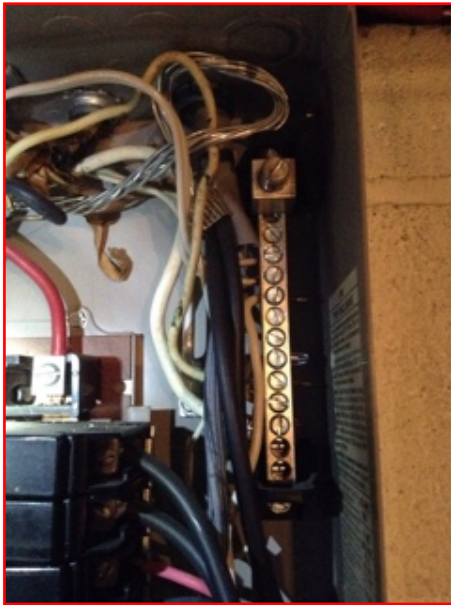
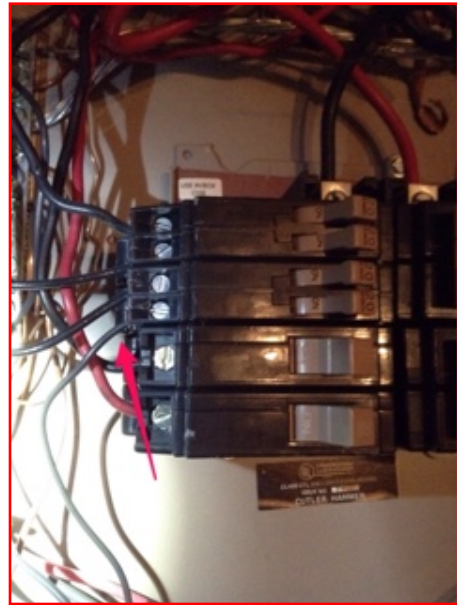
8) Sub panel should be evaluated by licenced electrician .
